MINI-FOCUS ISSUE: INTERVENTIONAL COMPLICATIONS AND  
THEIR MANAGEMENT

# Balloon-Expandable TAVR Prosthesis Dislocates Into the Ascending Aorta

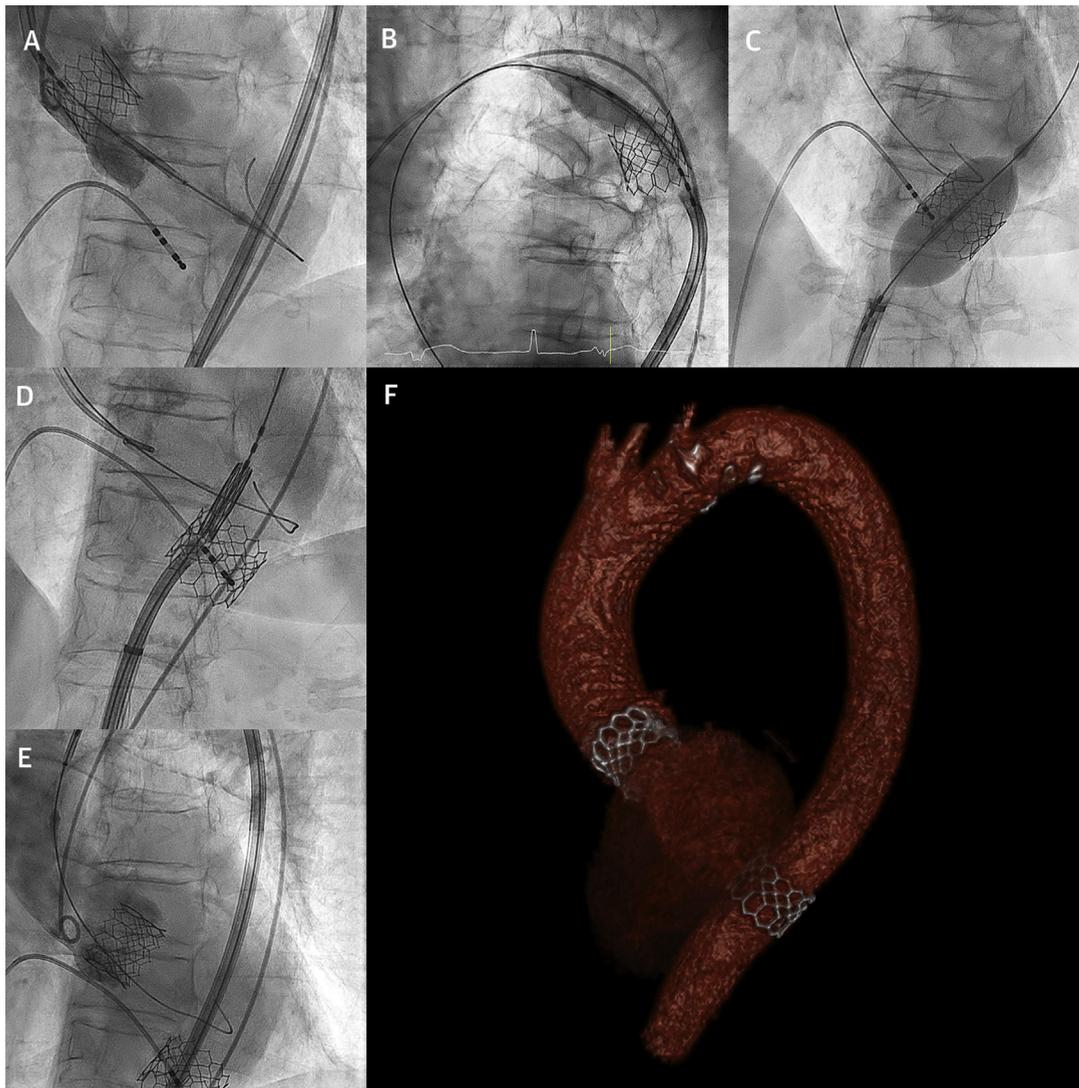
**FIGURE 1** Arteriography of Procedure and 3D CT of Reconstruction

Transfemoral TAVR was performed under local analgesia only and was uneventful until the actual valve deployment. During valve deployment, performed under rapid pacing (180 beats/min), the pacemaker lost capture for a single beat after which a longer diastolic filling period occurred (arrow in [Video 1 \[moment A\]](#)) and the partially expanded prosthesis was forced out of the aortic annulus and dislocated into the sinus of Valsalva ([Figure 1, Video 1 \[moment A\]](#)). After consultation with experienced TAVR operators and cardiac surgeons and reviewing the pre-procedural computed tomography (CT) angiography images for aortic diameters, the prosthesis was passed with the predilation balloon. Using the partially inflated balloon as an anchor, the dislocated prosthesis was delicately migrated through the aortic arch into the descending aorta, where the aortic diameter matched the diameter of the fully expanded 26-mm SAPIEN 3 prosthesis. In this location, the dislocated prosthesis was fully expanded using the aforementioned balloon ([Figure 1, Video 1 \[moment C\]](#)). A second SAPIEN 3 prosthesis was passed through the first ([Figure 1, Video 1 \[moment D\]](#)), after which it was successfully placed in the aortic position ([Figure 1, Video 1 \[moment E\]](#)), without any important prosthetic dysfunction.

Arteriography of the procedure (A to E) and 3-dimensional (3D) reconstruction of thoracic computed tomography (CT) imaging (F). See [Video 1](#).

**FOLLOW-UP.** Next-day CT imaging revealed no damages to the aortic wall. Three-dimensional reconstruction of these CT images is shown in [Figure 1F](#). The patient had an uneventful recovery and was discharged homeward 3 days post-procedure.

in experienced hands. In this case, the complication of dislocation of the prosthesis was caused by loss of capture of the temporary transvenous pacemaker lead and was treated successfully by retracting it toward the abdominal aorta, without any extra complications.
